CONNECTICUT COASTAL BASIN
EAST HAVEN-BRANFORD, CONNECTICUT
LAKE SALTONSTALL DAM
CT 00115

PHASE I INSPECTION REPORT
NATIONAL DAM INSPECTION PROGRAM

AUGUST, 1979

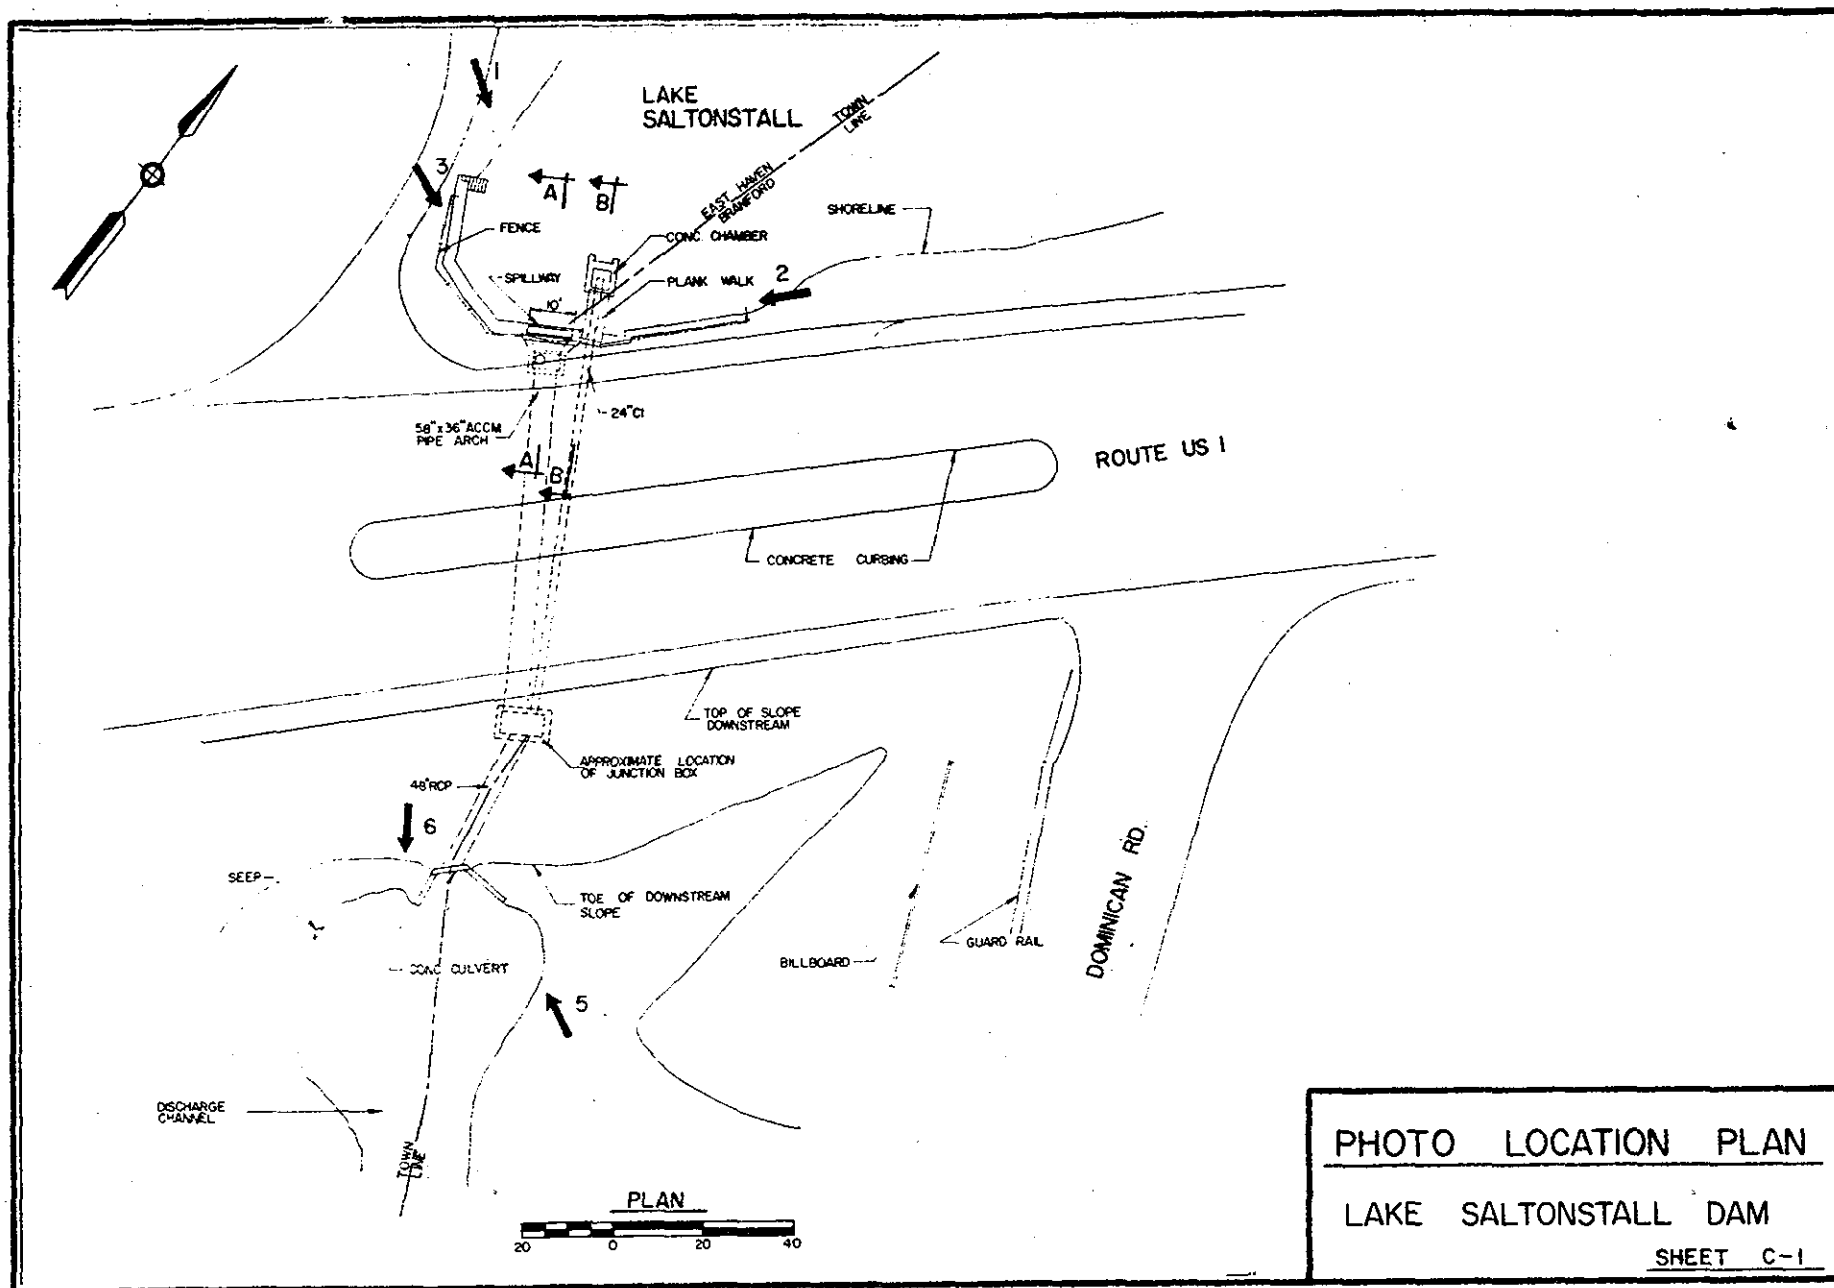
Crest - The crest of the earthfill dam accomodates U.S. Highway 1 (Photo 1). No misalignment of the crest was observed. Several cracks across the top were noted in the highway pavement which were most likely formed due to traffic loads.

PHOTO 1 - General view of upstream face of dam.
